**NORWAY/UNITED STATES DESIGN PROTECTIVE
AIRCRAFT SHELTER (PAS) QUANTITY-DISTANCE
PROGRAM 1/3-SCALE TEST SERIES**

**Volume I of V
PAS 1-4 Summary**

Final Report

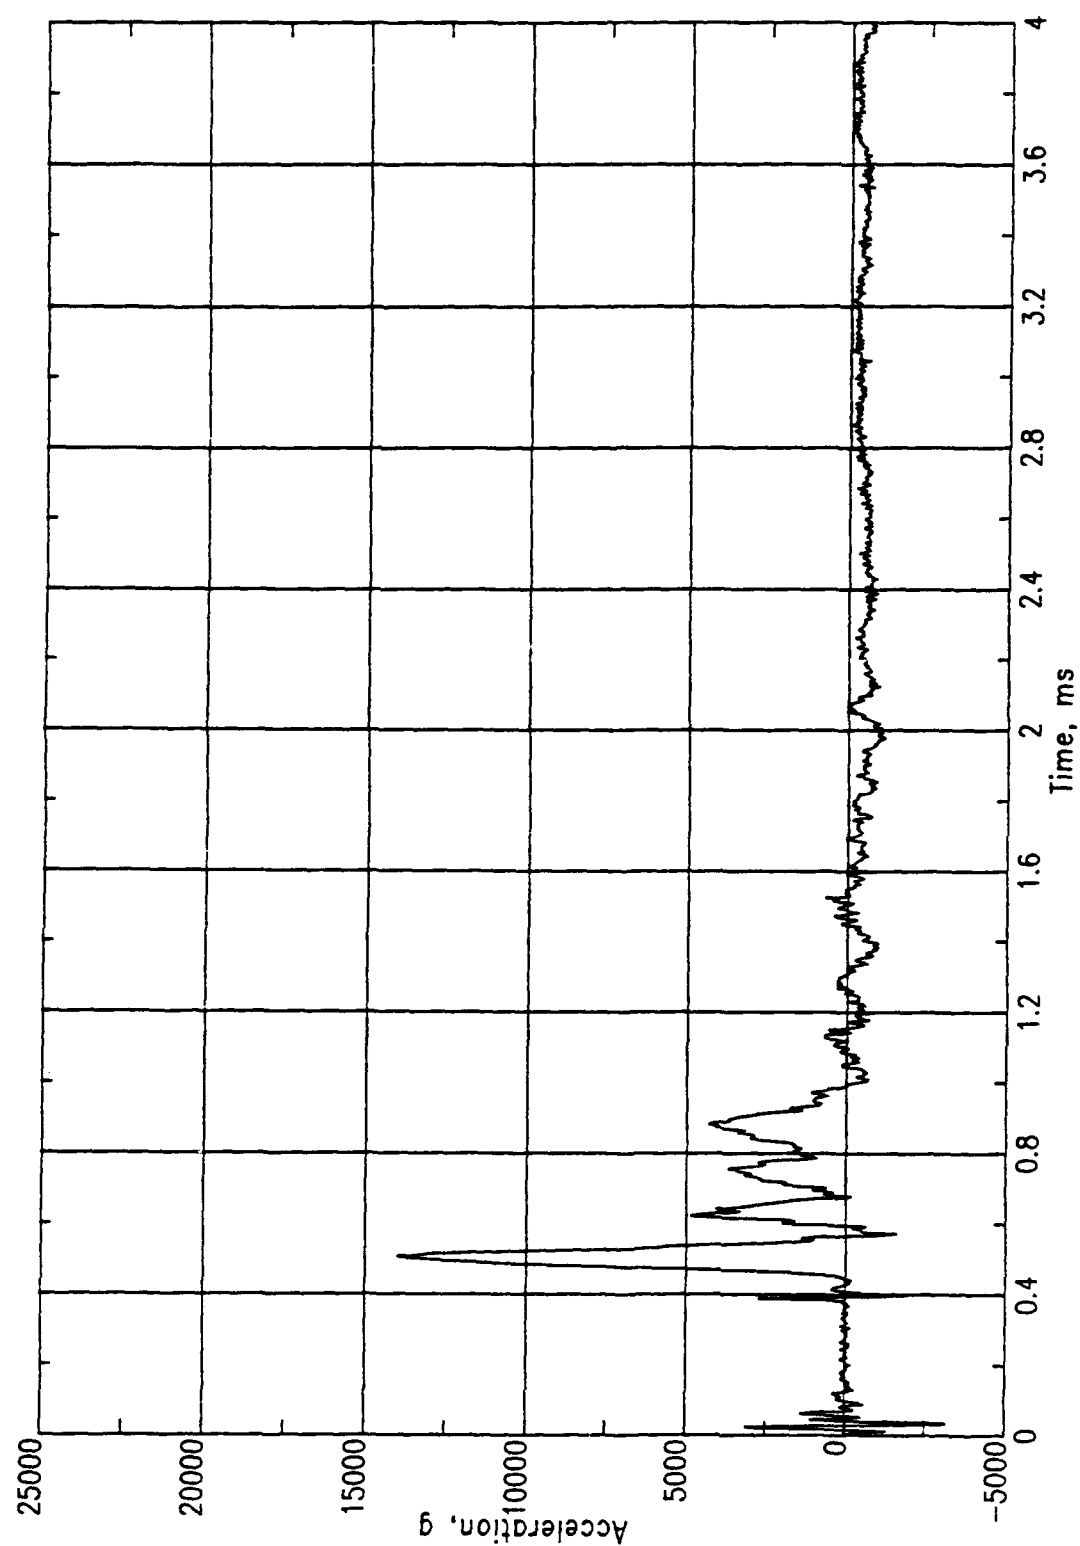
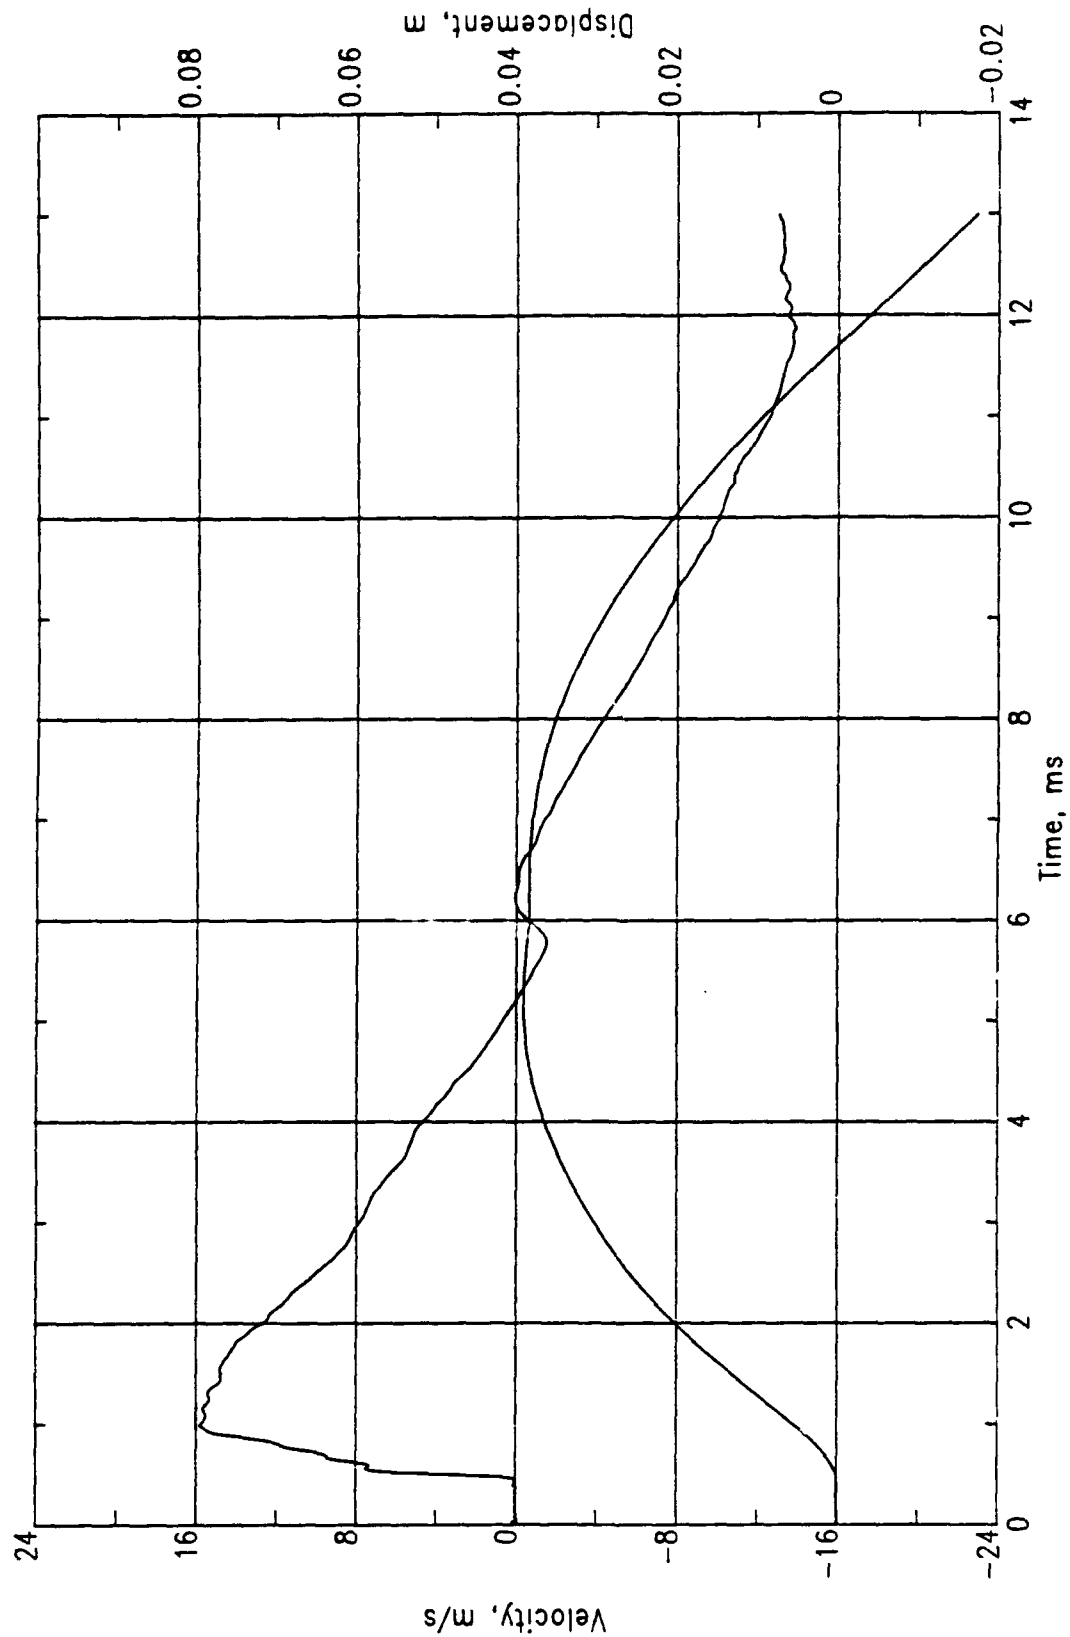
Figure 269. PAS-4, MN 1601.

Three accelerometers were mounted on the exterior surface of the arch in the same cross-sectional plane that included the GZ. The sensing axes of all accelerometers were oriented to measure radial accelerations. Measurement Number 1601 was made at the crown of the arch right over GZ. Figure 269a shows a peak radial acceleration of about 14,000 g for MN 1601. Figure 269b, a plot of the first and second integrals of the accelerometer record for MN 1601, shows a peak radial velocity of 15.8 m/s during the

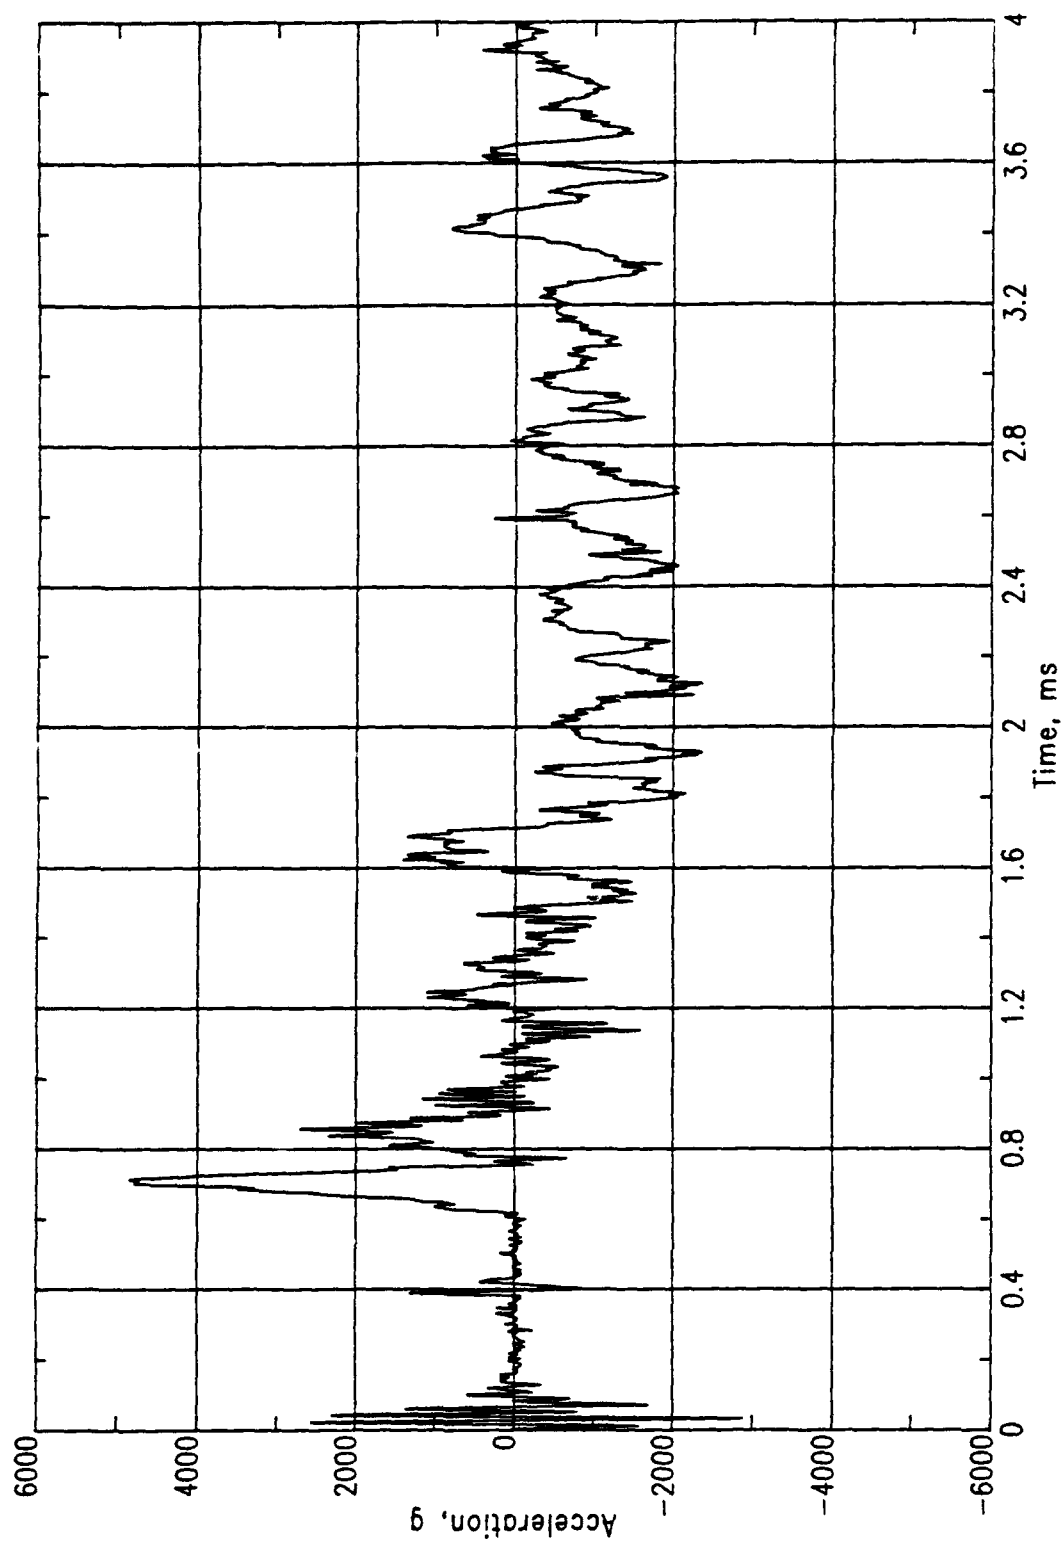
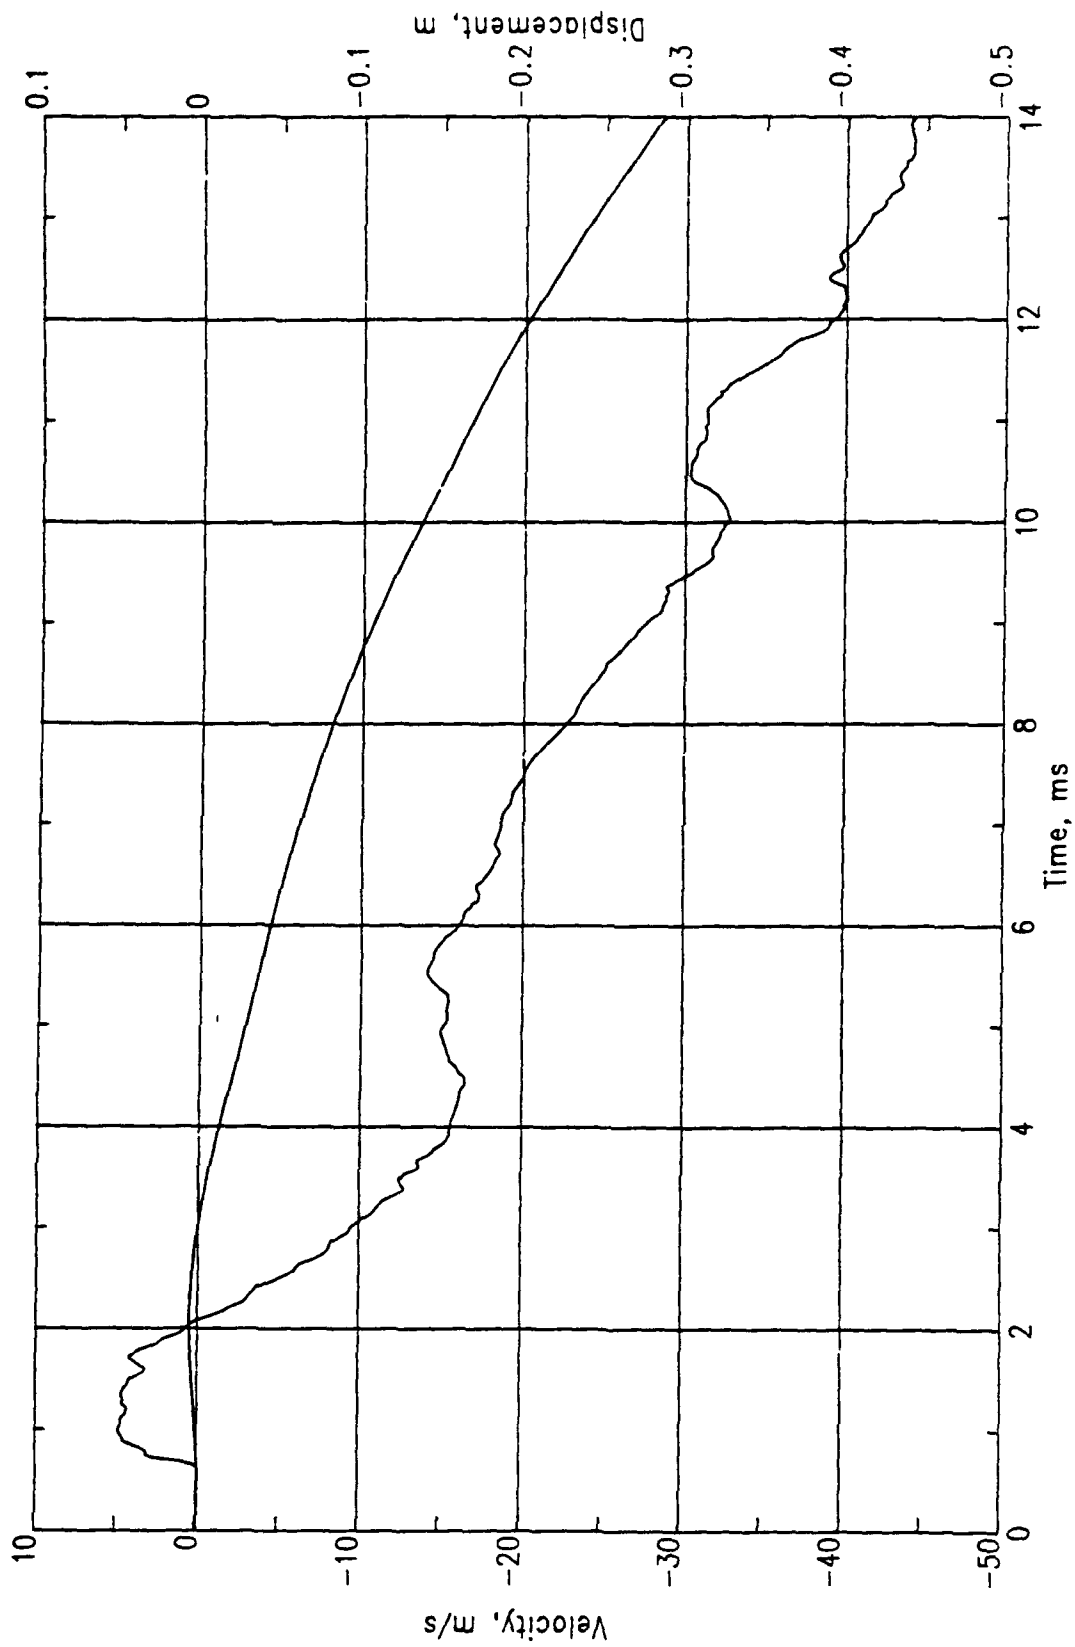
Figure 270. PAS-4, MN 1603.

first 2 ms of the record. This data channel failed at 13.6 ms. Measurement Number 1603 failed at 15.2 ms, but it recorded a peak acceleration of 4800 g (Fig. 270a). Figure 270b shows a peak velocity of 4.7 m/s within the first 2 ms for this gage. Measurement Number 1605 recorded a peak of 7000 g before failing at 34 ms (Fig. 271a). Figure 271b shows a peak velocity of 8.8 m/s in the first 4 ms for MN 1605. All of the peak velocities obtained from integration of accelerometer records are much lower than those obtained from analysis of high-speed photography. Since these velocity peaks occur before structure breakup, their validity is questionable. Peak velocities shown for later times are subject to even greater uncertainties because of baseline shifts in the accelerometer records.

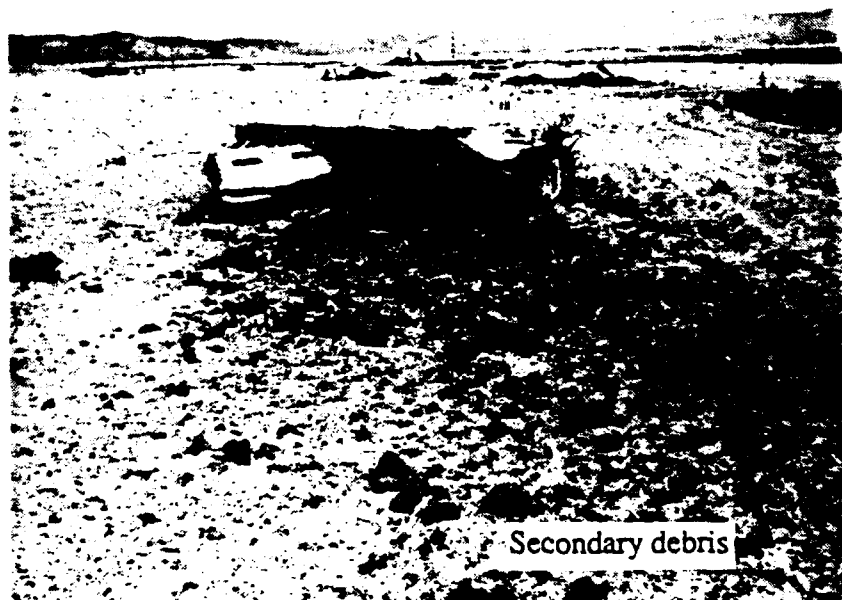
It was fairly easy to locate the areas of secondary debris produced when the sections of the arch impacted the ground (Fig. 278). Where two or more arch sections were close to each other, one area including all the pieces could be defined. Ten areas containing secondary debris were identified. The boundaries of the areas were marked and surveyed. The boundary surveys for the 10 areas are shown in Figure 279.

Figure 278. Secondary debris from large arch section, PAS-4.

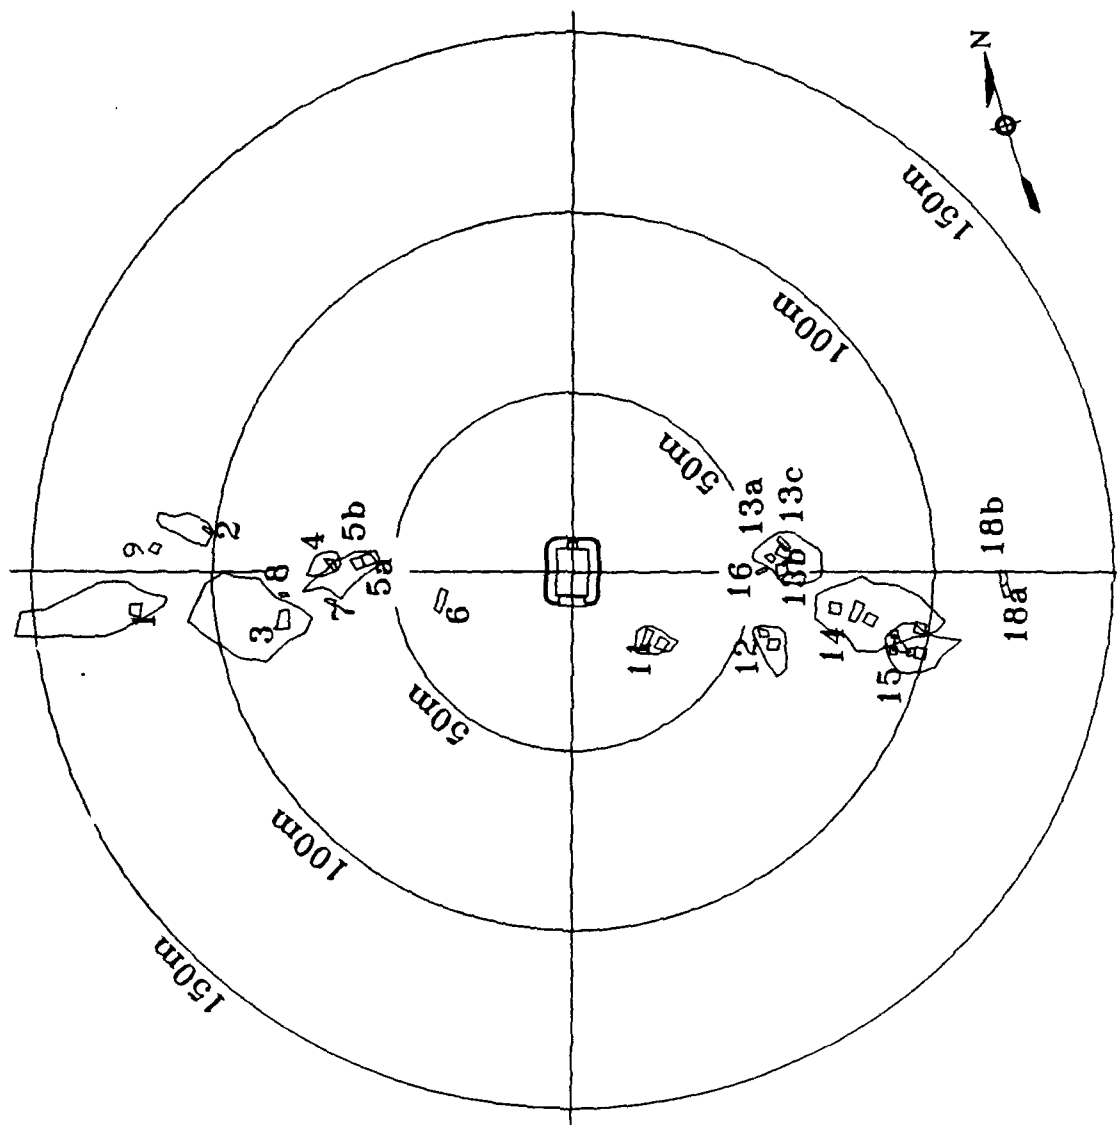
Figure 279. Boundaries of secondary debris from large arch sections, PAS-4.

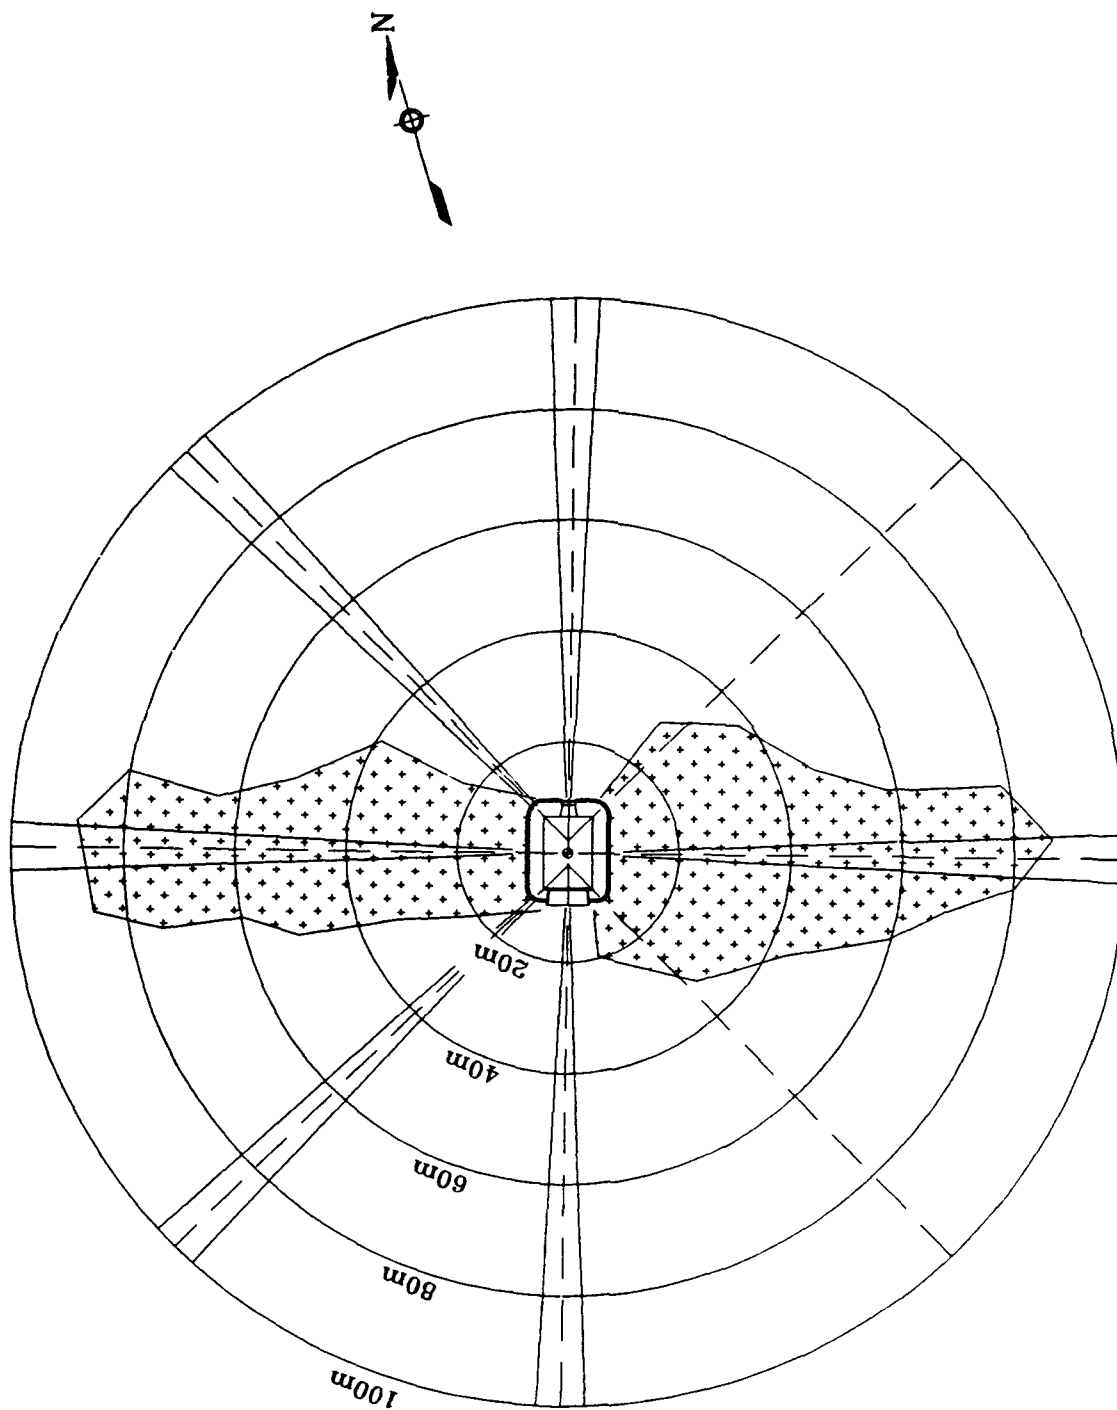
One of the more noticeable results of the test was the relatively large amount of rock from the berm scattered around the structure (Fig. 285). The distribution density of the rock far exceeded the concrete debris, particularly to the sides of the structure. As noted in the discussion of structural response, most of the rock debris came from an area adjacent to the structure. It is estimated that the volume of rock ejected during the test was about 15-20 percent of the total rock berm on either side of the arch. The limits of the rock distribution were surveyed and are illustrated in Figure 286.

Figure 286. Distribution of rocks from berm, PAS-4.

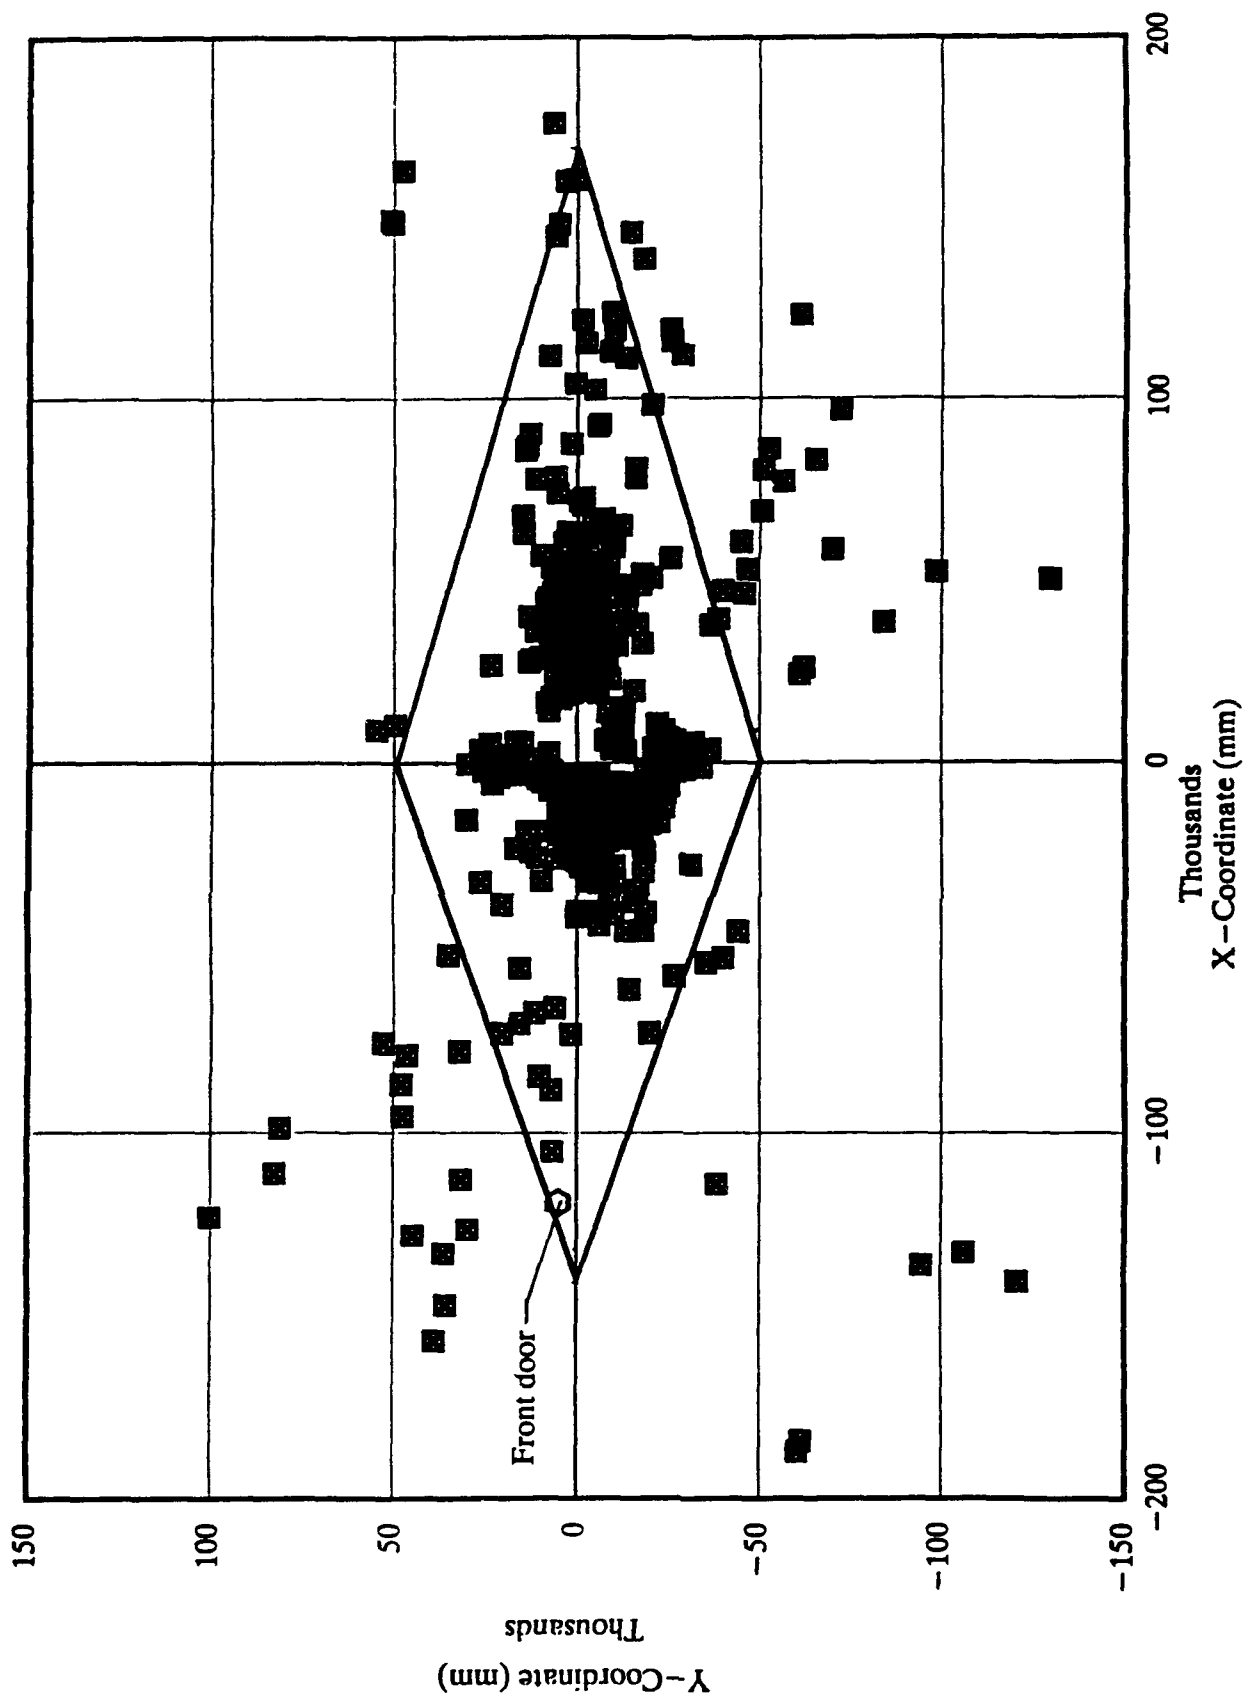
7.2.1.3 PAS-3—The majority of the debris recovered was generally distributed along the longitudinal axis of the shelter, rather than to the sides. For example, a diamond drawn with one axis 140 m long from the center of the shelter toward the front, one axis 170 m from the center to the back of the shelter, and the two side axes 50 m long from the center, would encompass 95 percent of all the debris produced (Fig. 287).

Figure 287. Suggested hazard boundary geometry, PAS-3.

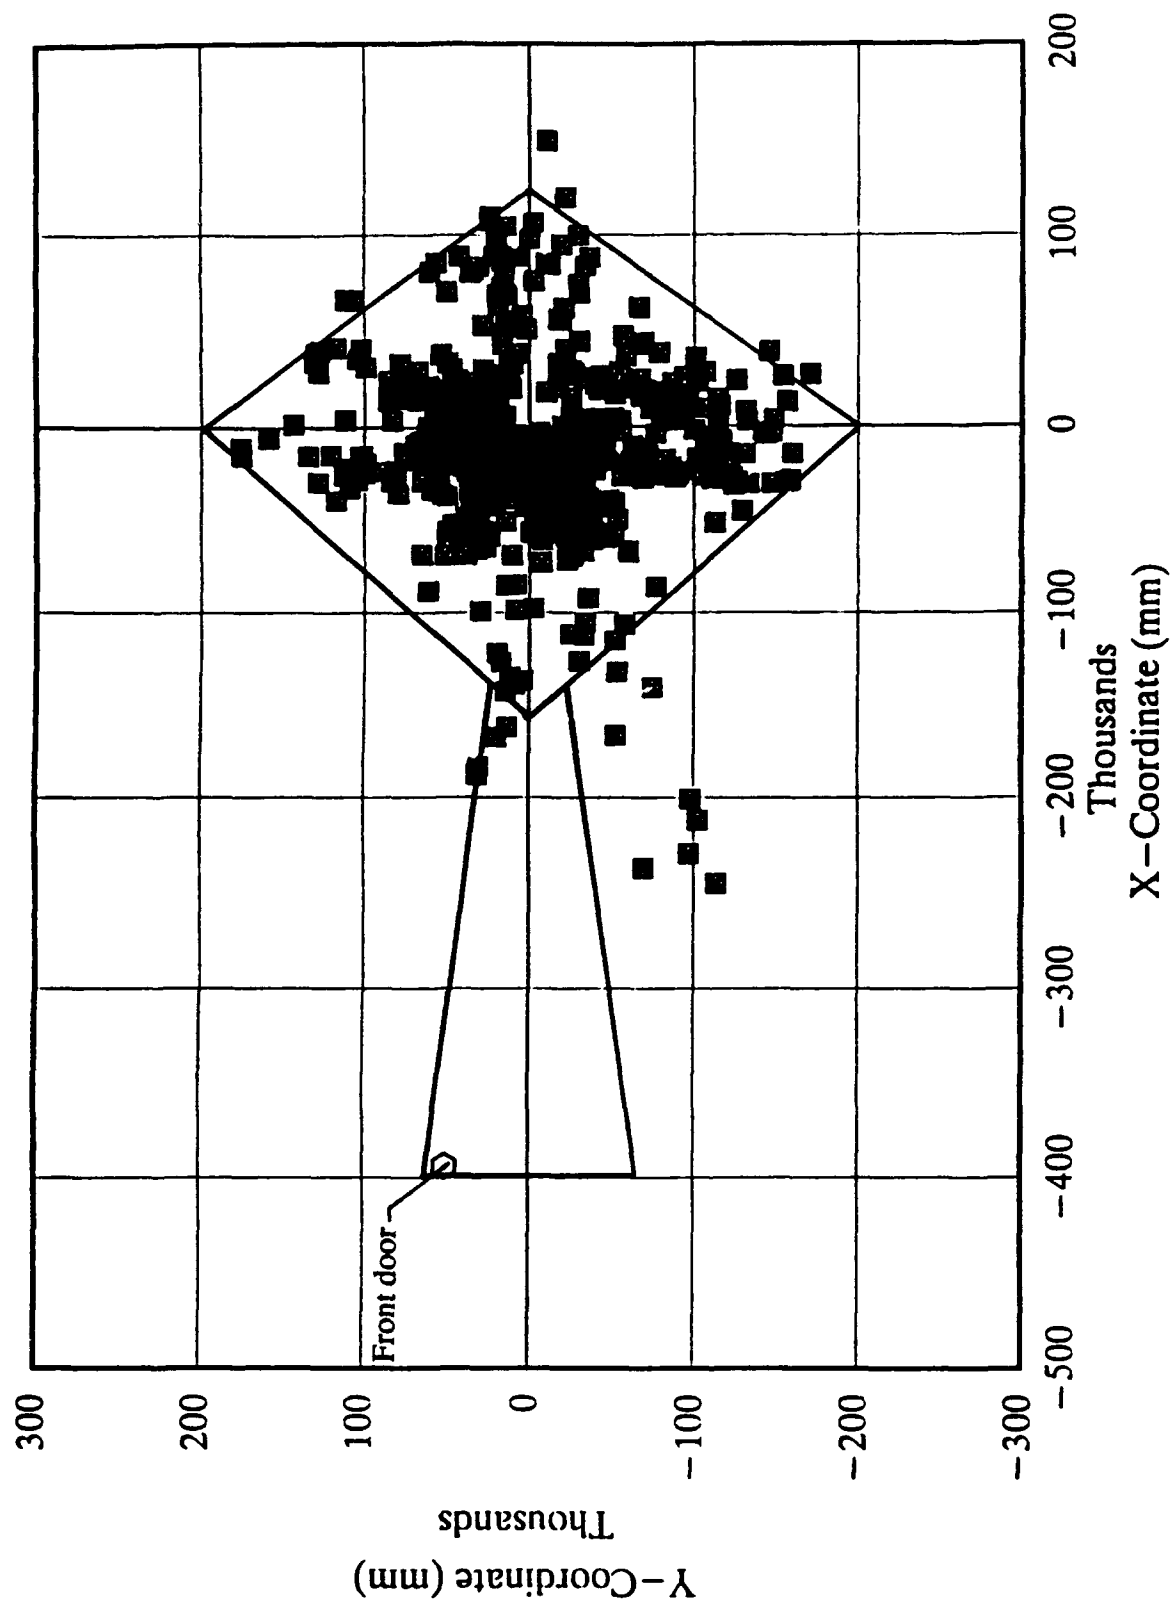
7.2.1.4 PAS-4—In comparison to PAS-3, the debris from this test was distributed about the same distances to the front and back of the shelter but almost three times as far to the sides. For example, a diamond drawn with axes of 170 m to the front, 115 m to the back, and 200 m to the sides, would enclose 98 percent of the debris (Fig. 288).

Like PAS-3, the debris recovered at the sides of the PAS-4 shelter appeared to originate from the arch. The debris to the back came from the exhaust port and backwall; the debris found toward the front came from the parapet and wingwalls.

Figure 288. Suggested hazard boundary geometry, PAS-4.
